## Locating Leaks

### Infrared technology can help uncover roof moisture problems

By Jeffrey L. Gadd | Photos courtesy of Vision Infrared Services

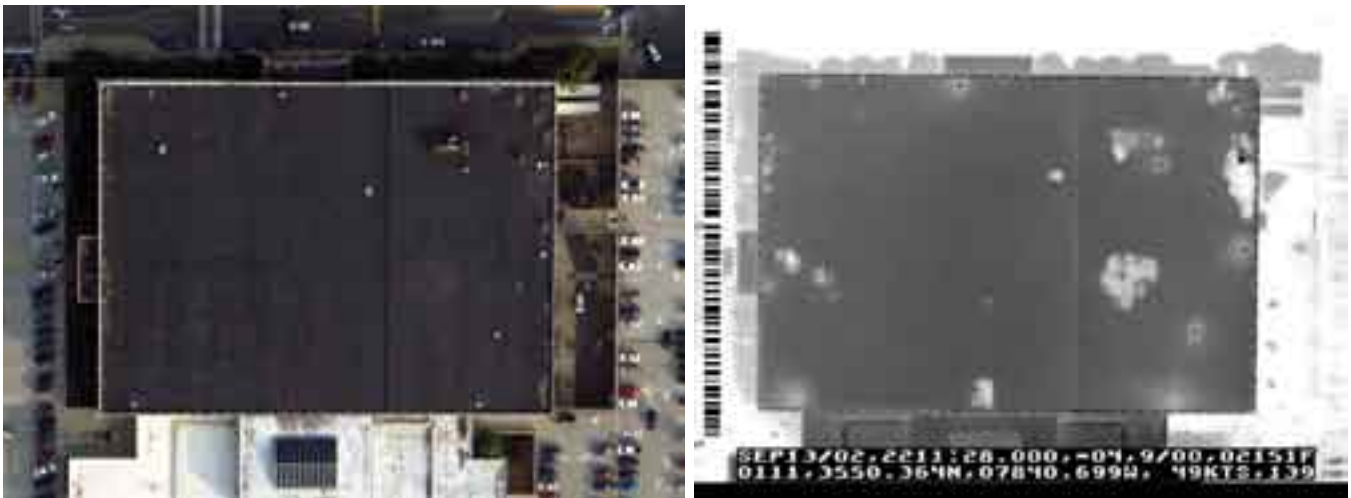
**TWO VIEWS** Infrared imaging (right) can reveal problem spots on roofs not normally visible to the naked eye (left).

During the day, the sun radiates energy onto the roof and into the roof substrate, and then at night, the roof radiates the heat back into outer space. This is called radiational cooling. Areas of the roofs that are of a higher mass (wet) retain this heat longer than that of the lower mass (dry) areas. Infrared imagers can detect this heat and “see” the warmer, higher mass areas, during the “window” of uneven heat dissipation.
